© National Dam Inspection Program
MARKUNAS DAM
River Basin

NDI PA-01114
DER 50-063

PERRY COUNTY, PENNSYLVANIA

PHASE I INSPECTION REPORT
NATIONAL DAM INSPECTION PROGRAM

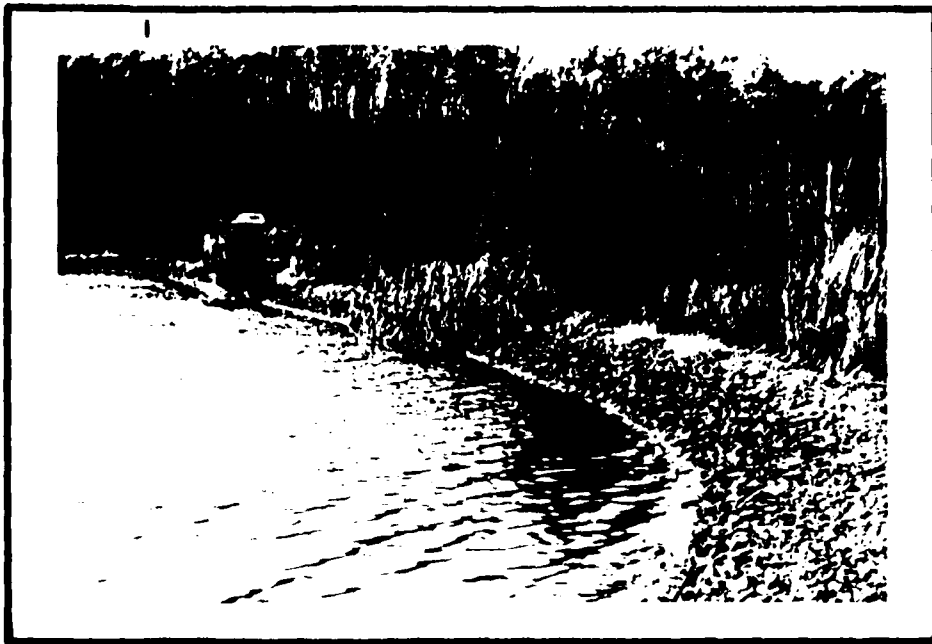
UPSTREAM SLOPE AND DROP INLET - NO. 2

The upstream slope above the normal pool elevation is covered with high weeds, some trees and brush. There were no indications of wave damage or erosion on the slope. The pool level was 2.7 feet below its normal elevation at the time of inspection.

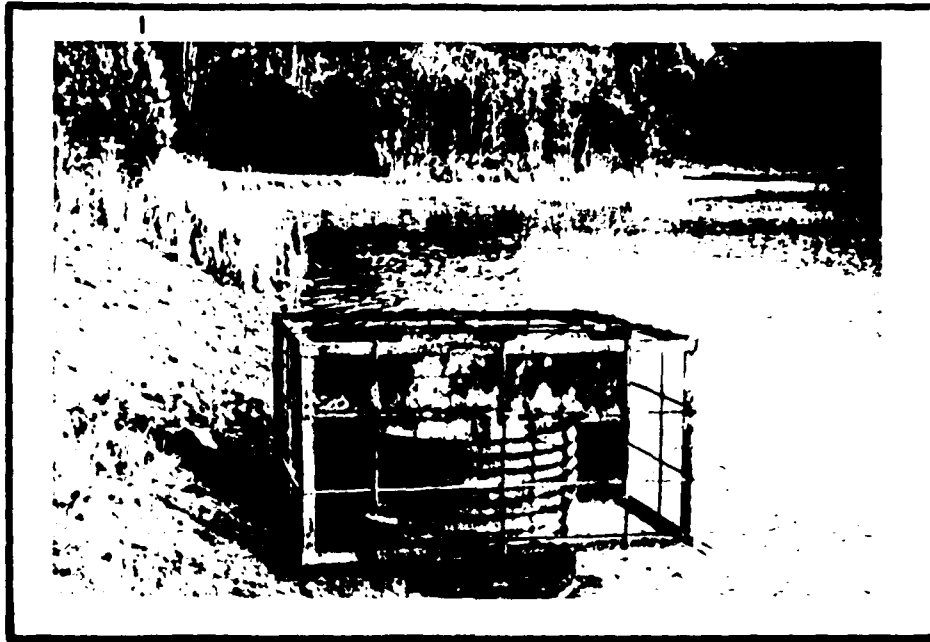
DETAIL OF DROP INLET - NO. 4

The principal spillway consists of a 42-inch vertical drop inlet corrugated metal pipe (Photograph No. 4). To prevent clogging of the intake, a metal screen has been placed over the top of the pipe. The clearance of the screen over and around the inlet appears to be adequate to prevent a serious restriction of the opening. The vertical pipe is about 20.5 feet in height and is located about 16 feet upstream from the centerline of the dam. A 24-inch corrugate pipe extending through the embankment provides the outlet of the principal spillway (Photograph No. 5). Water discharges into a small pool at the end of this pipe. It appeared that at the upstream side of the 42-inch vertical pipe, stoplogs closed an opening at the bottom of the inlet. Some water was seeping through these logs. It is assumed that an upstream horizontal pipe was used during construction as a temporary outlet.

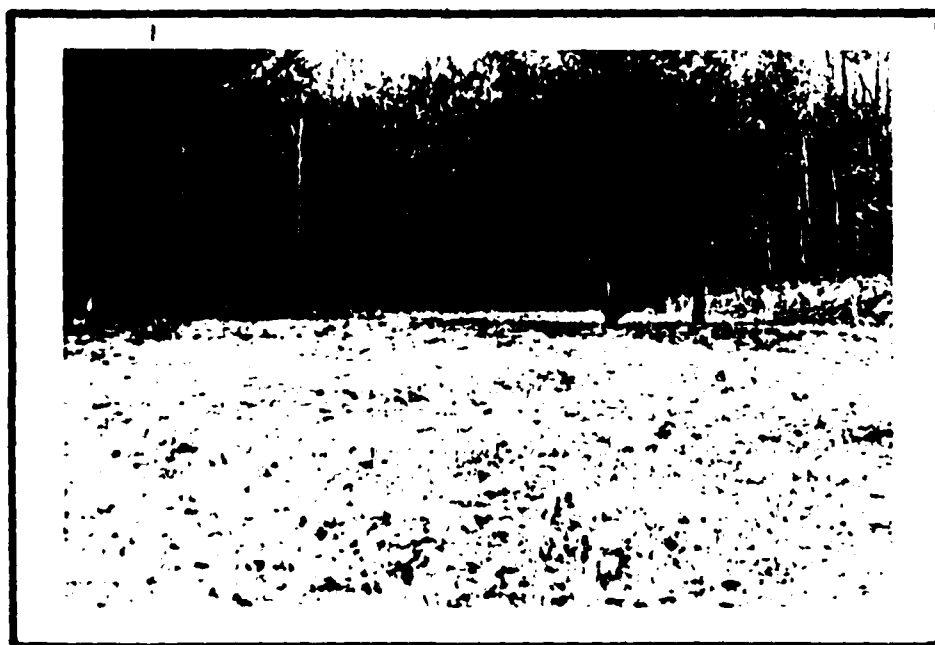
EMERGENCY SPILLWAY LOOKING DOWNSTREAM - NO. 7

An emergency spillway is located in the right abutment. It appears that this spillway was created by excavating natural ground. The approach channel is directly from the reservoir, and the spillway has a wide, flat, sparsely sodded channel which discharges into a downstream wooded area away from the embankment.

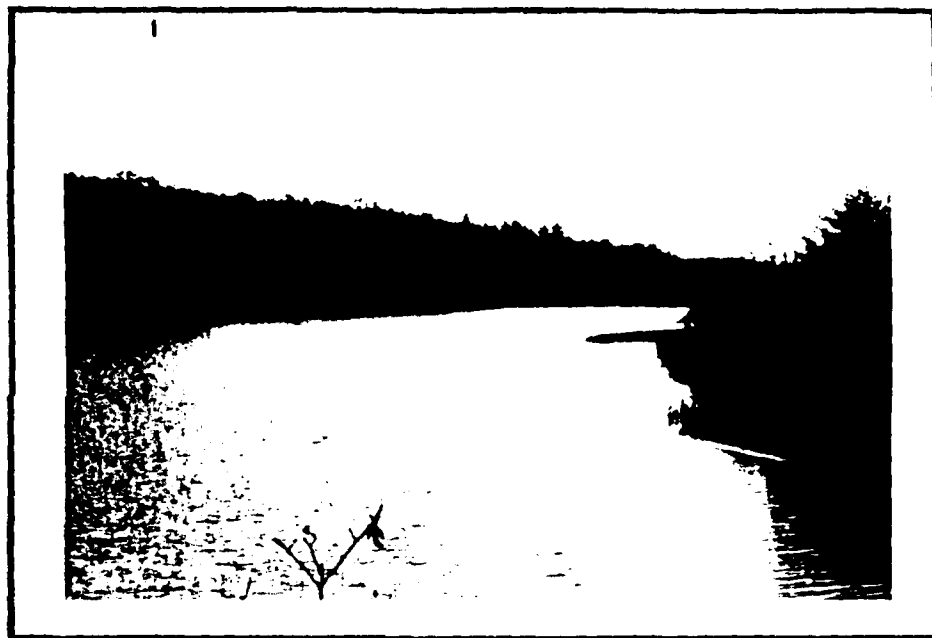
RESERVOIR - NO. 8

The reservoir area has moderate slopes on the left side consisting of abandoned farm land. The right side of the reservoir consists of steeper wooded slopes. The banks are stable and sedimentation is not expected to be a serious problem.
